NPIC/R-1349/63

June 1963

PHOTOGRAPHIC INTERPRETATION BRIEF

# DECK CARGO ABOARD THE SOVIET MERCHANT SHIP [REDACTED]

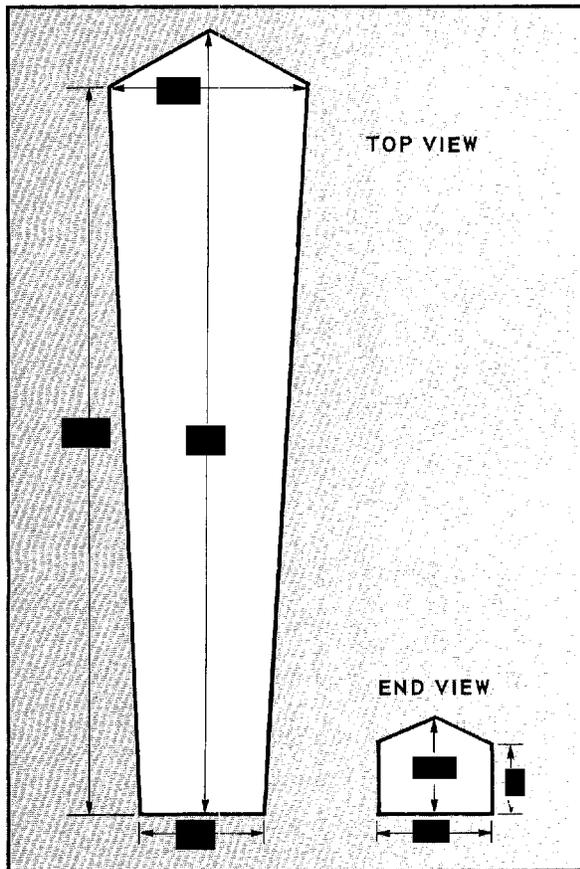
FIGURE 1. WOODEN STRUCTURE ON DECK OF [REDACTED]

A study of photography obtained by the US Navy, on [REDACTED] of the Soviet merchant ship [REDACTED], inbound for Cuba, reveals six crude wooden structures presumably covering deck cargo (Figures 1 and 2). The approximate dimensions of the wooden structures are given on Figure 1. Height dimensions are for the structure itself, at the small end, and do not reflect height above deck.
